How to Make Durable and Aesthetic Temporaries

In Search of the Perfect Temp

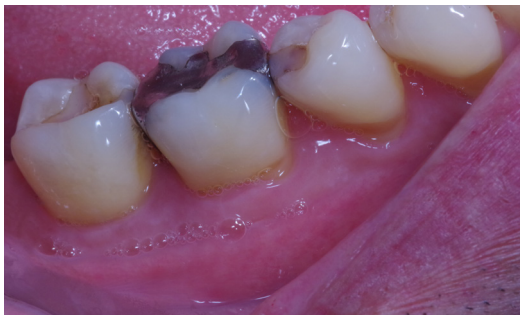
Figure 1. Shows lower left first molar (#19) with failed amalgam restoration and eroded cervical area

Most of the temporaries I make are for single unit crowns. In the following case, I fabricated a temporary crown for a first molar (#19) with a failed amalgam restoration and eroded cervical area (Figure 1) for a healthy, active, 50-year-old male patient. I used the Tuff-Temp Plus Add-on material to block out the eroded cervical area (Figure 2) so that I could take a PVS impression of the tooth and surrounding teeth (Figure 3). Figure 4 shows the temporary two weeks after placement. The temp did not need to be relined thanks to the low shrinkage rate of Tuff-Temp Plus.

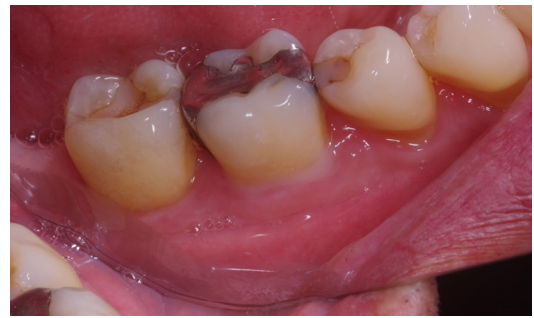
Figure 2. Tuff-Temp Plus Add-on material is used to block out the eroded cervical area on tooth #19

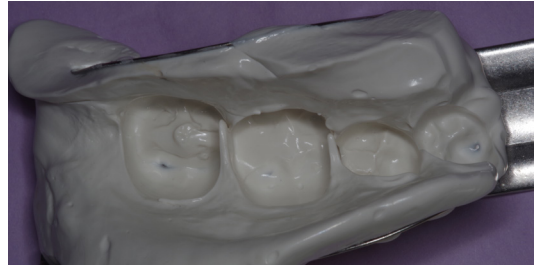
Figure 3. PVS impression of tooth #19 and adjacent teeth

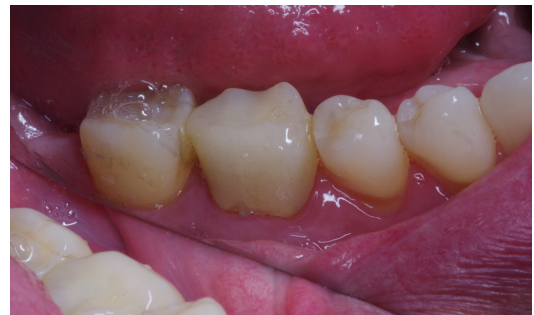
Figure 4. Shows temporary two-weeks after placement

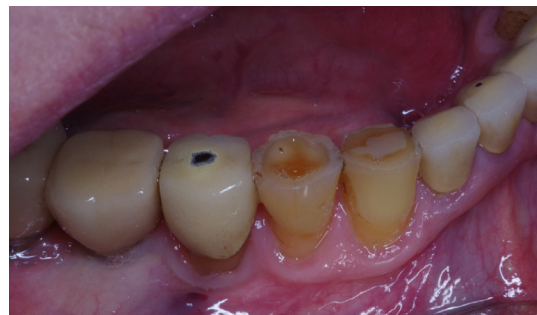
Figure 5. Shows second premolar (tooth #29) with external resorption

An 81-year-old male patient presented with a second premolar (#29) with external resorption (Figure 5). In the pre-operative radiograph the resorption appears as a black spot on the root of #29 (Figure 6). The prognosis was poor because of external resorption present on the root. The long-term success rate of treatment, even with root canal therapy, was not good when compared to extraction and placement

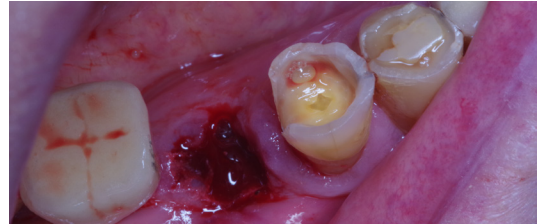
Figure 7. Tooth #29 is extracted and the adjacent tooth #28 is prepared to support the temporary restoration

Following the extraction, tooth #28 was prepared (Figure 7), etched and a bonding agent was applied. Next a thin protective layer of stackable composite (ACTIVA Presto, Pulpdent) was placed in the prepared area (Figure 8).

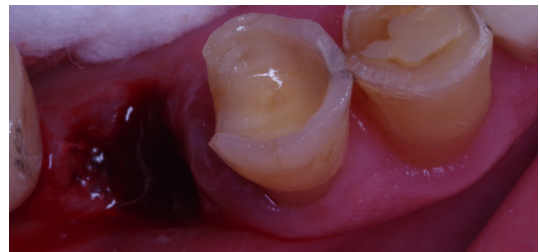
Figure 8. After etching and applying a bonding agent to tooth #28, a thin layer of ACTIVA Presto is placed in the preparation

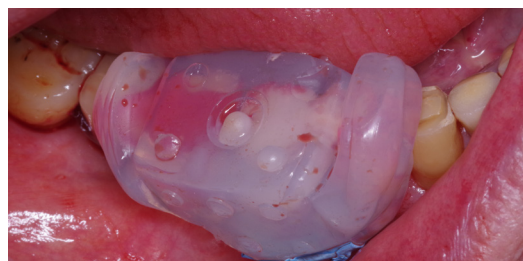
Figure 12. With the impression serving as a template, Tuff-Temp Plus is injected through the hole to create the temporary and incorporate the fiber post

Then it was time to create the temporary using the impression as a template. After removing the impression from the tray, I made a small hole over the occlusal surface of tooth #29 to allow for injection molding (Figure 11). With the fiber post in place in the adjacent tooth, I placed the impression over the treatment area and injected Tuff-Temp Plus A3.5 shade through the hole to create the temporary and incorporate the post (Figure 12).

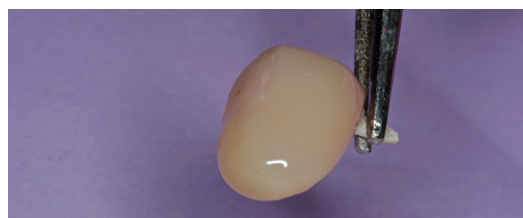
Figure 14. The Tuff-Temp Plus Add-On material is applied to the apical aspect to create an ovate pontic and finished with Tuff-Temp Plus Glaze

Using the Tuff-Temp Plus Add-on material, which has a flowable consistency, I built up the apical aspect of the restoration to make an ovate pontic. The temporary was finished with Tuff-Temp Glaze - a viscous and glossy material that eliminates the need for polishing (Figure 14).

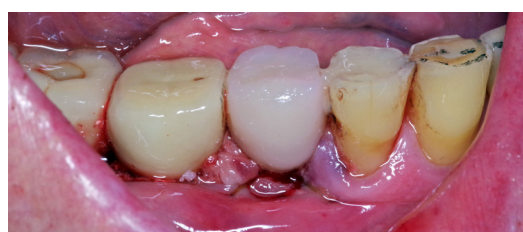
Figure 15. Shows completed temporary cantilever bridge

The temporary bridge was seated and ACTIVA Presto was placed over the fiber post and then light cured. I marked the occlusal surface of the temporary with Accufilm (Parkell) and adjusted the occlusion using a football-shaped diamond. Figure 15 shows the completed temporary. The restoration has been in place for 3 months with no reported issues.

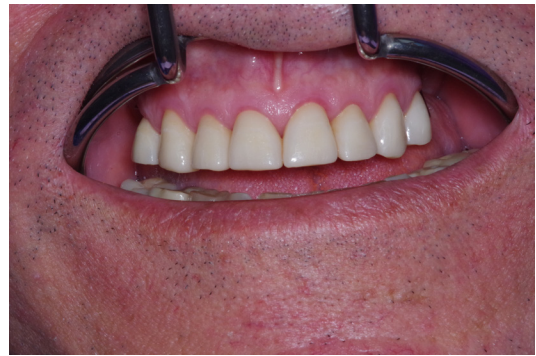
Figure 16. Pre-operative image with retractor

Sometimes circumstances force patients to stay in provisionals for extended periods of time. Shortly before the COVID-19 shutdown in my home state of Florida, a 65-year-old male patient asked to have his existing crowns on teeth #5-#12 replaced with longer, whiter crowns. Figure 16 shows a retracted view of the gingival tissues and emergence profiles of the provisional restorations.

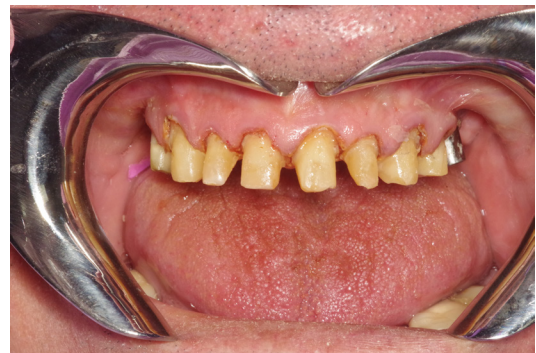
Figure 17. After removing secondary decay, the teeth were prepared for the temporary restoration

After sedating the patient with nitrous oxide, I cut off his existing zirconia crowns, revealing secondary caries. The decay was removed and the teeth were prepared for the temporary restoration (Figure 17).

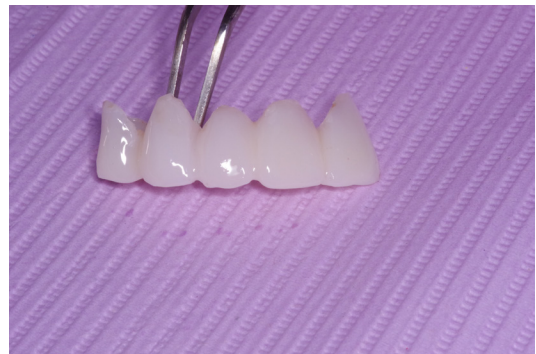
Figure 18. Temporary restoration for teeth #5-#9 made with Tuff-Temp Plus Bleach shade

Since the patient's teeth were divergent, I fabricated the provisional in two pieces, using Tuff-Temp Plus bleach shade, a pressure formed matrix (Ministar, Great Lakes Technologies), and Teflon tape. I created the first piece by placing Tuff-Temp Plus into the section of the matrix for teeth #5-#9 (Figure 18). Once complete, I placed Teflon tape over the first piece and injected Tuff-Temp Plus into the remaining portion of the matrix to create the second provisional for teeth #10-12.

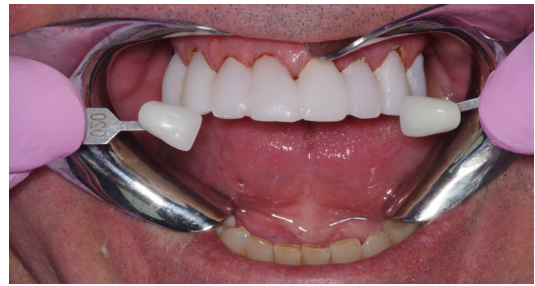
Figure 19. Temporaries are cemented and cleaned

Tuff-Temp Plus grinds and powders to feather margins without softening or gumming up burs. After trimming and glazing the temporary restorations with Tuff-Temp Glaze the temporaries were cemented in place with GC Temp Advantage (GC America) and excess cement was easily removed from the glazed surface (Figure 19).

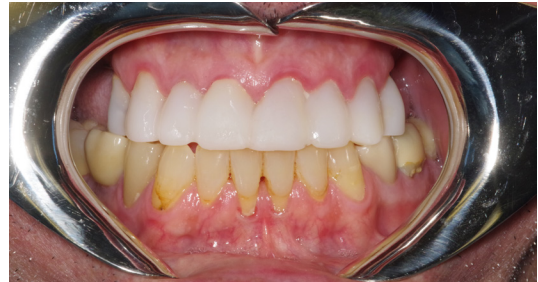
Figure 20. Temporary restoration with Tuff-Temp Plus more than two months after initial placement

Under normal circumstances this patient would have returned in about two weeks to remove the temporaries and receive the final restorations. Due to the COVID-19 shutdown, however, these provisionals remained in service for over two months without any additional treatment. There had been no need to reline them, the margins were excellent, and the tissues remained healthy. The Tuff-Temp Plus restorations never came loose, maintained nice aesthetics, and thanks to the rubberized-resin chemistry they did not chip or fracture. Figures 20 and 21 show the temporary restorations more than two months after initial placement.

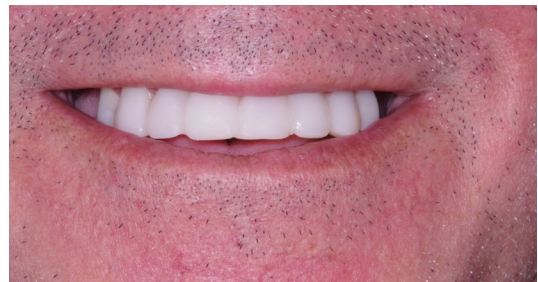
Figure 21. Shows temporary restorations nine weeks after placement
