A PRACTICAL GUIDE TO MINERAL- ENRICHED COMPOSITES

Robert A. Lowe, DDS

PREVENTION OF EXTENSION WITH MINERAL-ENRICHED COMPOSITES

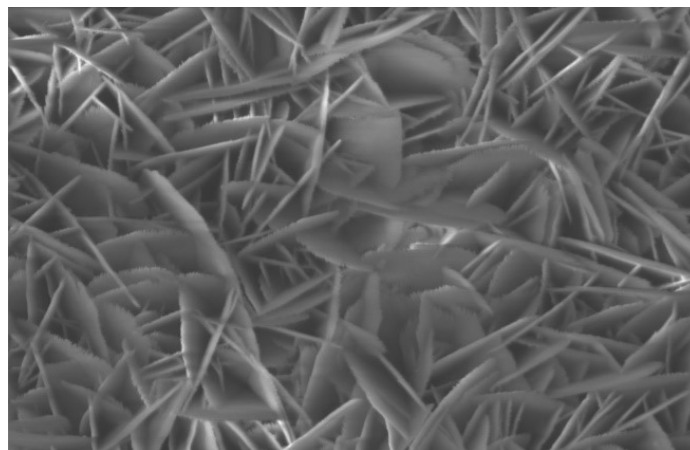
SEM of ACTIVA Presto stored in phosphate buffered solution (a saliva substitute) for 21 days shows surface precipitation of Calcium Phosphate (CaP). Source: SEMTech Solutions.

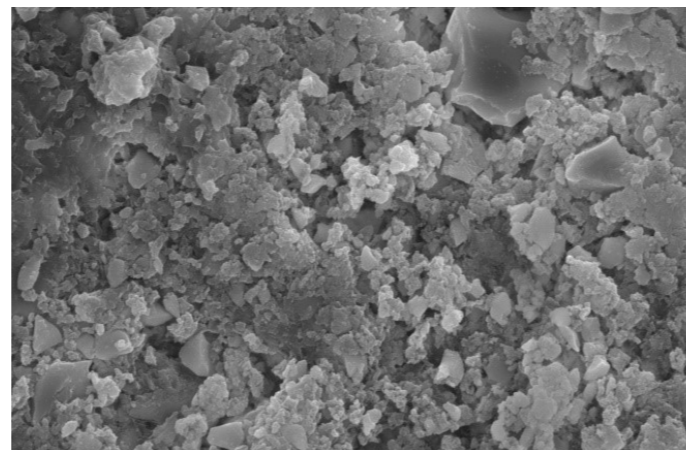
SEM of ACTIVA Presto stored in phosphate buffered solution (a saliva substitute) for 21 days shows an eight-fold increase in Calcium and Phosphate ion concentrations. Source: SEMTech Solutions

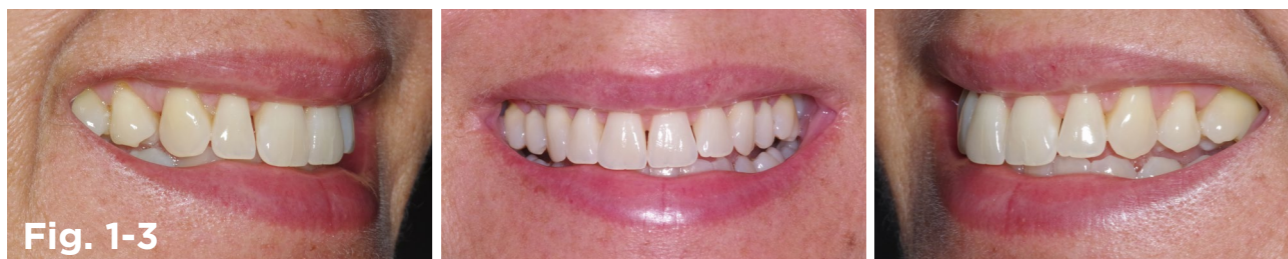
Fig. 1-3

54-year-old female patient with a history of periodontal disease had recession due to bone loss, resulting in black triangles between her central and lateral incisors.

A 54-year-old woman with a history of periodontal disease had experienced bone loss resulting in visible recession, most notably in the form of black triangles. Having received treatment for her periodontal disease, the patient wanted to close all the black triangles in her maxillary anterior teeth (Figure 1 through Figure 3) to improve the esthetics of her smile.

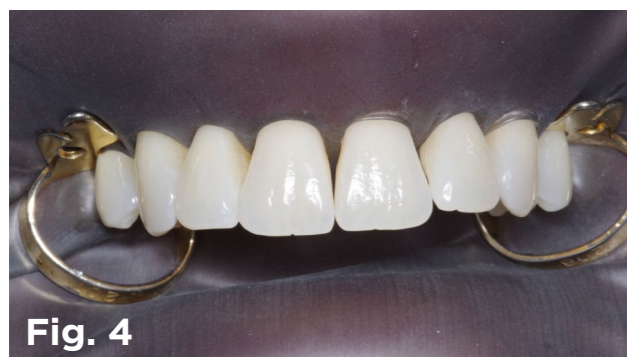
Fig. 4

A heavy weight rubber dam was placed and inverted to maximize gingival retraction while maintaining optimal conditions for bonding.

A heavy weight rubber dam was placed and inverted to maximize gingival retraction while maintaining optimal conditions for bonding (Figure 4). Since these teeth were caries-free there was no need for preparation or anesthesia. The teeth were thoroughly cleaned using pumice followed with a medium fine interproximal strip to remove any remaining plaque from the tooth surfaces.

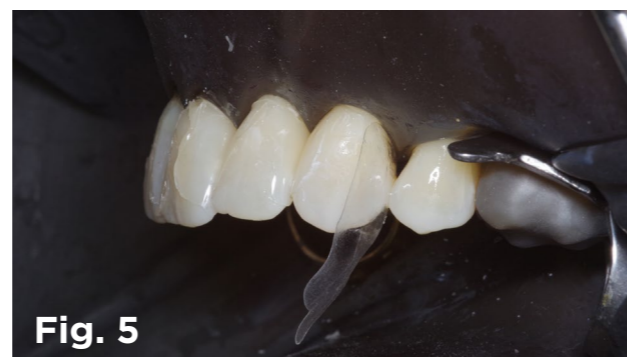
Fig. 5

After cleaning with pumice and prophylaxis paste, a medium fine interproximal strip was used to remove any remaining plaque from the tooth surfaces.

The black triangles were then treated one gap at a time using Bioclear matrices (Bioclear Matrix Systems) (Figure 5 and Figure 6), wedges (Figure 7), and ACTIVA Presto (Pulpdent Corporation), a mineral-enriched composite that releases calcium, phosphate, and fluoride, and contains a shock-absorbing, rubberized resin. The teeth were etched for 20 seconds with Etch-Rite (Pulpdent Corporation) and rinsed before a bonding agent was applied (Figure 8). Since there were contacts at the incisal edge, an instrument was used to mechanically separate the teeth.

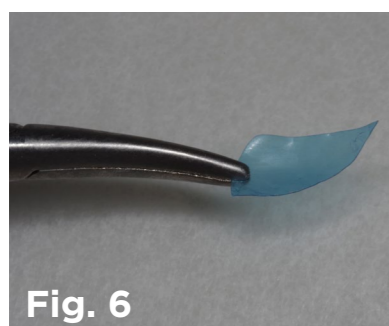
Fig. 6

The Bioclear matrix.

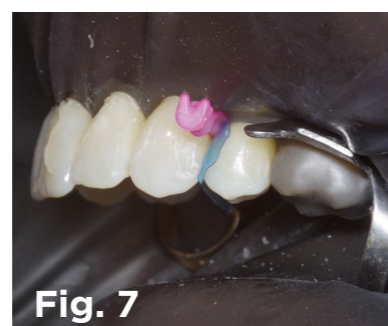
Fig. 7

A wedge was placed next to the Bioclear matrix.

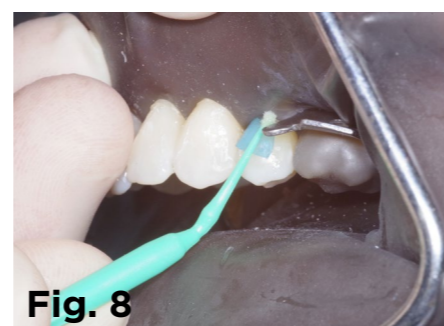
Fig. 8

The teeth were etched for 20 seconds with Etch-Rite (Pulpdent) before applying a bonding agent.

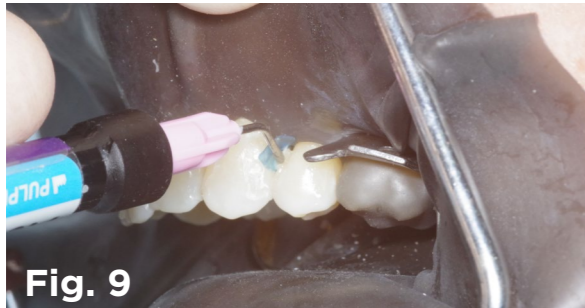
Fig. 9

Placement of ACTIVA Presto using Bioclear matrix.

Next ACTIVA Presto shade A3.5 was placed (Figure 9), light cured, and contoured with a fine diamond bur, followed with a Montana Jack Scaler (Paradise Dental Technologies) to remove excess bonding agent and any overhangs. Final polishing was done using a Sof-Flex Disc (3M) followed by medium to super fine finishing strips. Figure 10 and Figure 11 show the final postoperative restoration with the rubber dam.

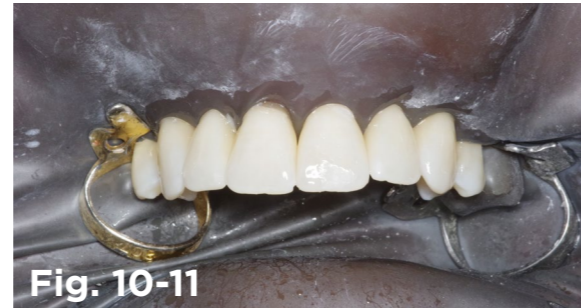
Fig. 10-11

Postoperative images of restoration with rubber dam.

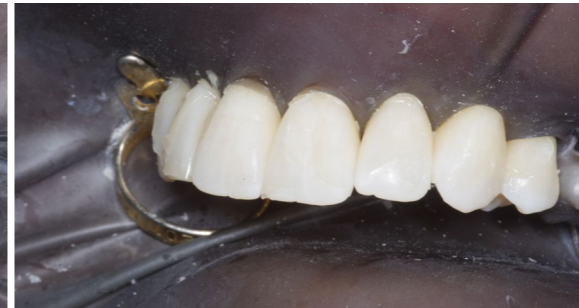
Fig. 12

Preoperative image of Class V restoration of tooth No. 4.

The patient had recession with erosion on tooth No. 4 (Figure 12).

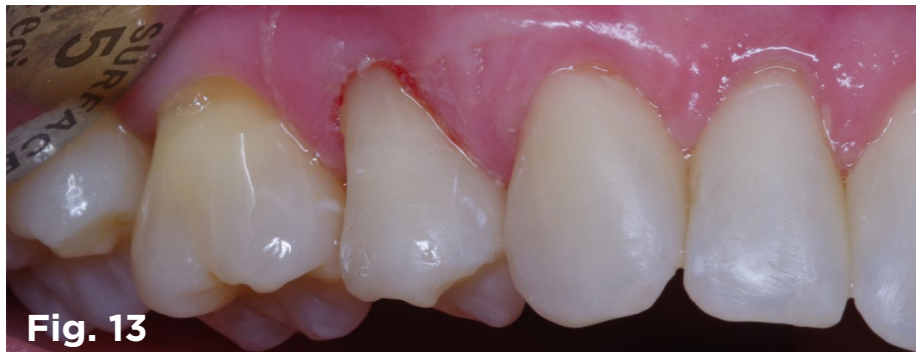
Fig. 13

Postoperative image of Class V restoration of tooth No. 4 using ACTIVA Presto shade A6 at the top of the gum line and shade A4 for the remainder of the restoration.

A Class V restoration was performed. Since tooth No. 4 was caries-free, the preparation was minimal, requiring only a 33.5 inverted cone bur while the tissue was gently retracted by placing Teflon tape in the sulcus. The Teflon tape does not bond to composite, facilitating clean-up. The tooth surface was etched for 20 seconds with Etch-Rite (Pulpdent) before placing a bonding agent. ACTIVA Presto shade A6 was placed at the highest part of the gum line followed by shade A4 for the remainder of the restoration. Due to the flowability of Presto, the two shades were blended at the interface to avoid a distinct delineation of the shades. The restoration was finished using a fine tapered diamond bur followed with Sof-Flex Discs (3M). Figure 13 shows the immediate postoperative restoration of tooth No. 4. Figure 14 through Figure 16 show the black triangle restorations at the one-week recall.

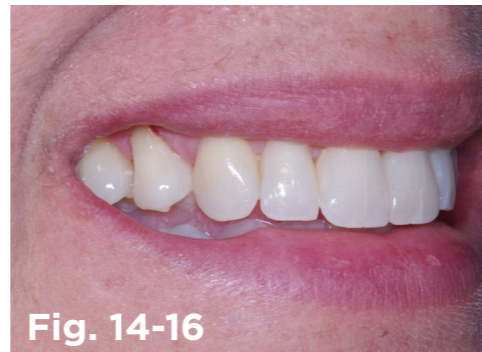
Fig. 14-16

Black triangle restorations at the one-week recall.

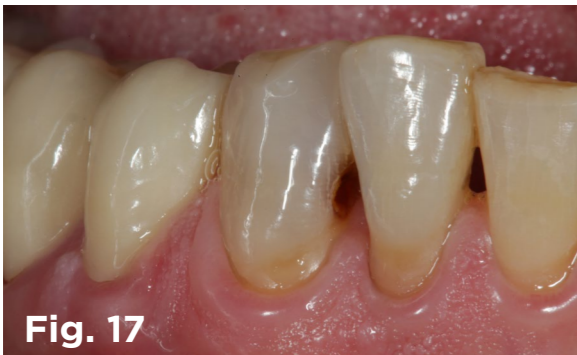
Fig. 17

Caries lesions can be seen on the mesial proximal surface of tooth No. 27.

An older patient presented with caries lesions on the distal proximal surface of tooth No. 26 (Figure 17) and the mesial proximal surface of tooth No. 27 (Figure 18). After establishing the outline form of the cavity preparation, infected dentin was removed using a polymer bur that is the exact Knoop hardness of healthy dentin (Smart Bur II, SS White). Figure 19 shows the preparation. A super pulsed diode laser (Gemini, Ultradent) was used to remove interproximal gingival tissues, creating a supragingival margin to facilitate matrix placement and application of the restorative material. A unique Mylar matrix (Bioclear) was used to better recreate the anatomic convex profile of the interproximal surface.

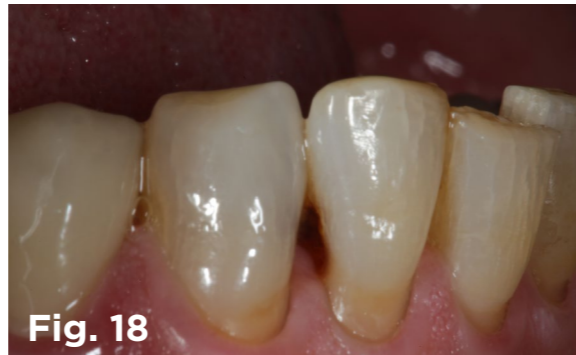
Fig. 18

Existing caries lesions are visible on the distal proximal surface of tooth No. 26.

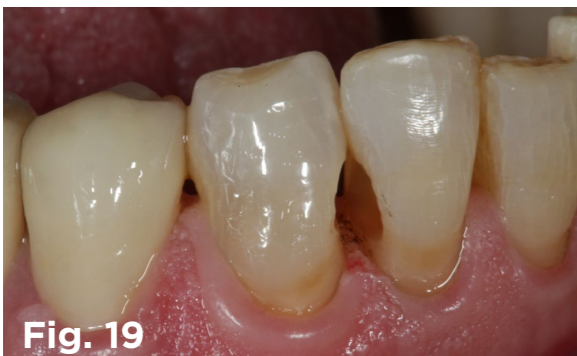
Fig. 19

Cavity preparations are shown on the distal surface of tooth No. 26 and the mesial surface of tooth No. 27.

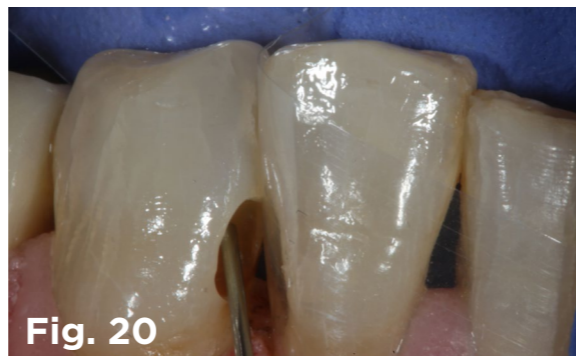
Fig. 20

ACTIVA Presto is injected into the preparation on the mesial surface of tooth No. 27.

ACTIVA Presto was injected to fill the preparation to the cavosurface margins (Figure 20). Once the matrix was adapted closely to the tooth and secured, the material was light cured per the manufacturer's instructions. Finishing was done using a fine carbide composite finishing bur (FG-7901, SS White) before final polishing with rubber composite polishing abrasives (A.S.A.P. All Access All Surface Polishers, Clinician's Choice). Figure 21 shows the final restoration immediately after placement. Two years later, the restorations appear to have "matured" and blend well with the surrounding tooth structure (Figure 22). The case demonstrates the composite material's ability to stack and hold its shape, and to integrate with the tooth structure to provide long-term esthetics and strength.

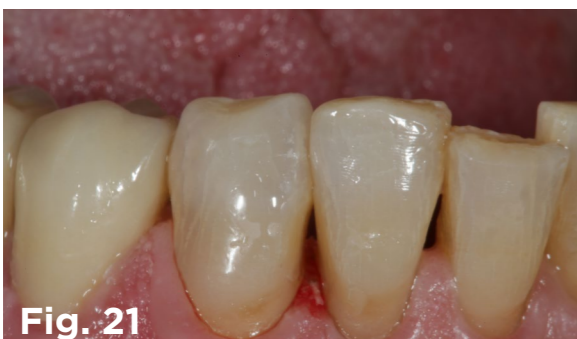
Fig. 21

Immediate postoperative image of ACTIVA Presto restorations placed in teeth Nos. 26 and 27.

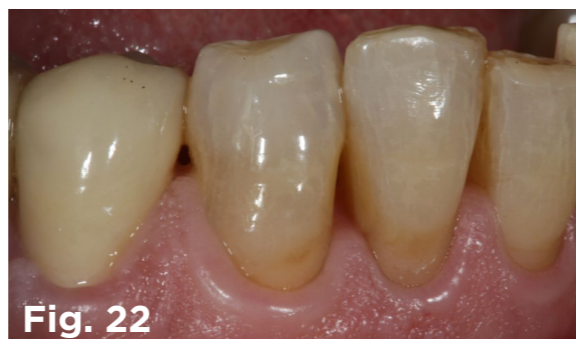
Fig. 22

Two-year postoperative image. The restorations blend well with the color of the surrounding tooth structure.

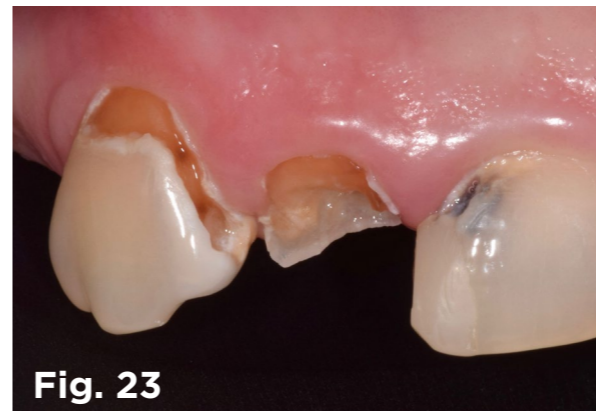
Fig. 23

Severe caries in teeth Nos. 6, 7, and 8, with tooth No. 7 broken at the gum line.

A 35-year-old female patient with a penchant for sugary drinks showed severe caries in teeth Nos. 6, 7, and 8. All three teeth were intact during the initial consultation, but when she returned several weeks later for treatment, tooth No. 7 had broken at the gum line (Figure 23) and had to be endodontically treated. Once the root canal was complete, medium grit diamond burs (50-60 microns) were used to access the caries, followed by a selective caries removal process. The infected dentin was removed from the axial walls of the cavity with sharp spoon excavators followed by carbide burs. The affected dentin was left intact and the floor of the preparation was covered with ACTIVA BioACTIVE-BASE/LINER. Tooth No. 7 was restored first, using a resin-reinforced fiber glass pin, Sycamore Wedge, Palodent Matrix (Dentsply Sirona), and ACTIVA Presto shade A2 (Pulpdent Corporation). After application of Clearfil SE Bond (Kuraray Noritake), the ACTIVA Presto was placed in four increments, starting with the proximal area before building up the vestibular and palatal aspects. Next ACTIVA Presto was used to restore teeth Nos. 6 and 8. The three teeth were contoured using low grit diamond burs (15-40 microns) and abrasive strips for the interproximal area and then polished with Twist Dia (Kuraray Noritake) and Unigloss Paste (Intensiv).

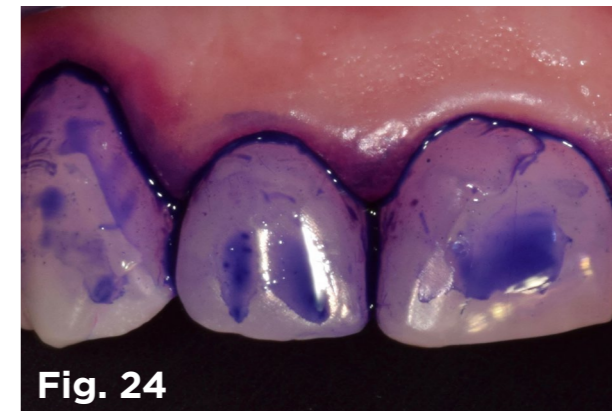
Fig. 24

Plaque disclosing Mira-2-Ton liquid (Hager & Werken) was applied to the restored teeth at the one-month recall appointment.

The patient returned one month later. Plaque disclosing Mira-2-Ton liquid (Hager & Werken) was applied to teeth Nos. 6, 7, and 8 (Figure 24) and then rinsed, revealing very little plaque in the areas around the restorations (Figure 25). Figure 26 shows the final restorations at the one-month recall appointment.

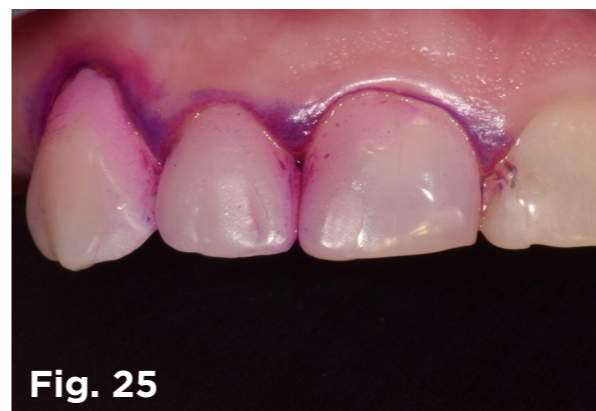
Fig. 25

Mira-2-Ton was rinsed, revealing very little plaque in the areas around the restorations.

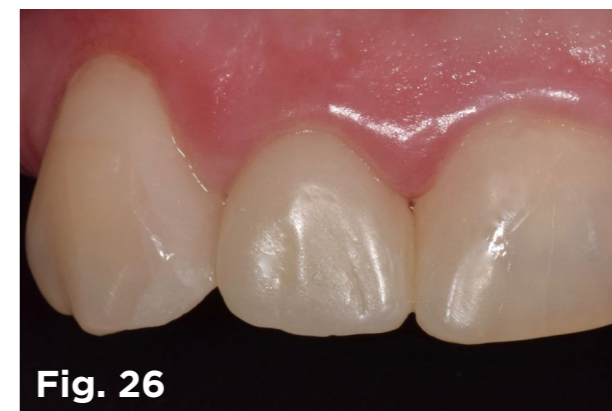
Fig. 26

Final restorations at one-month recall appointment.

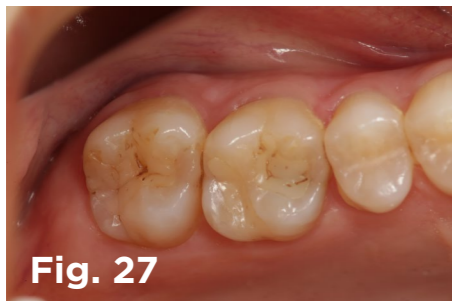
Fig. 27

Preoperative occlusal view of tooth No. 3 shows compromised mesial margin.

A patient who could not afford a crown received a direct restoration using the sandwich technique and mineral-enriched restorative materials. There was marginal failure in the area of an existing restoration of tooth No. 3 near the mesial marginal ridge (Figure 27). A portion of the mesial margin had been compromised due to fracture, and recurrent decay was diagnosed using Quantitative Laser Fluorescence (QLF) and verified clinically. Caries detection (SoproCare: Acteon) showed active caries

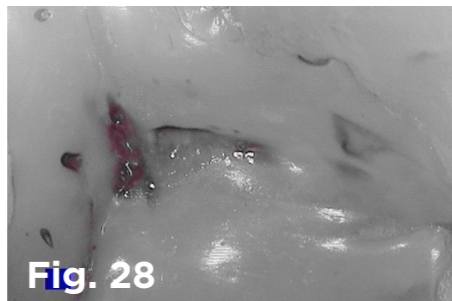
Fig. 28

Caries detection (SoproCare: Acteon) shows active caries lesion around a defective restorative margin on tooth No. 3.

lesion around a defective restorative margin on tooth No. 3 (Figure 28). Decay was visible upon removal of the defective restoration (Figure 29) and a Smart bur 2 (SS White Dental) was used to remove infected dentin only. The preparation was etched with 38% phosphoric acid (Etch Rite, Pulpdent Corporation) for 15 seconds and rinsed well. Excess moisture was removed using high-volume suction to avoid desiccating the dentin. An adhesive resin was applied to the dentin surface, air thinned, and light cured.

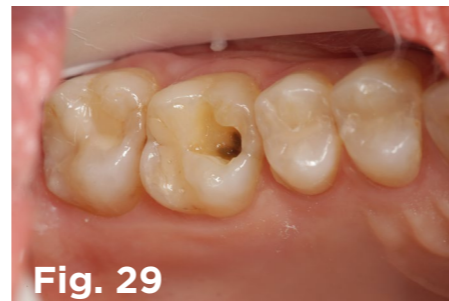
Fig. 29

Decay is visible upon removal of the defective restoration. Affected dentin is not removed.

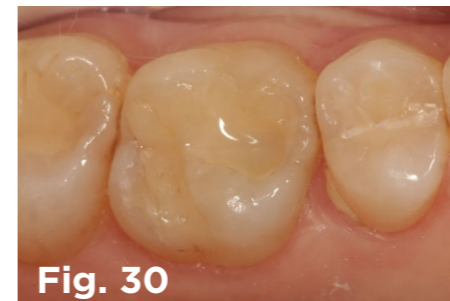
Fig. 30

Occlusal view of tooth No. 3 after placing ACTIVA BIOACTIVE-RESTORATIVE as a dentin replacement.

Next, ACTIVA BIOACTIVE-RESTORATIVE was placed in the cavity and light cured, leaving approximately 1.0-1.5 millimeters for the final layer of restorative material (Figure 30). ACTIVA Presto was chosen for the enamel replacement, since it is a mineral-enriched universal composite material with a stackable viscosity that holds its shape. Figure 31 is an occlusal view of the completed restoration on the surface of tooth No. 3.

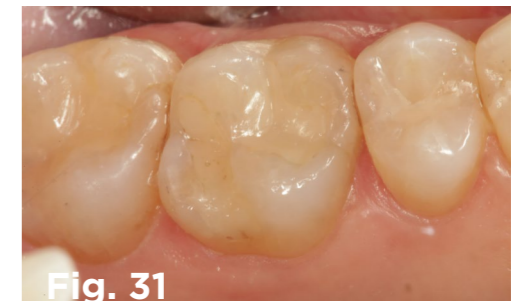
Fig. 31

Occlusal view of the completed restoration after placing ACTIVA Presto as the enamel layer. Note the anatomical form and high luster of ACTIVA Presto.
